MTI 74TR34

Design and Fabrication of Prototype System  
for Early Warning of Impending  
Bearing Failure

G. C. Marshall Space Flight Center  
National Aeronautics and Space Administration  
Huntsville, Alabama 35812

April, 1974

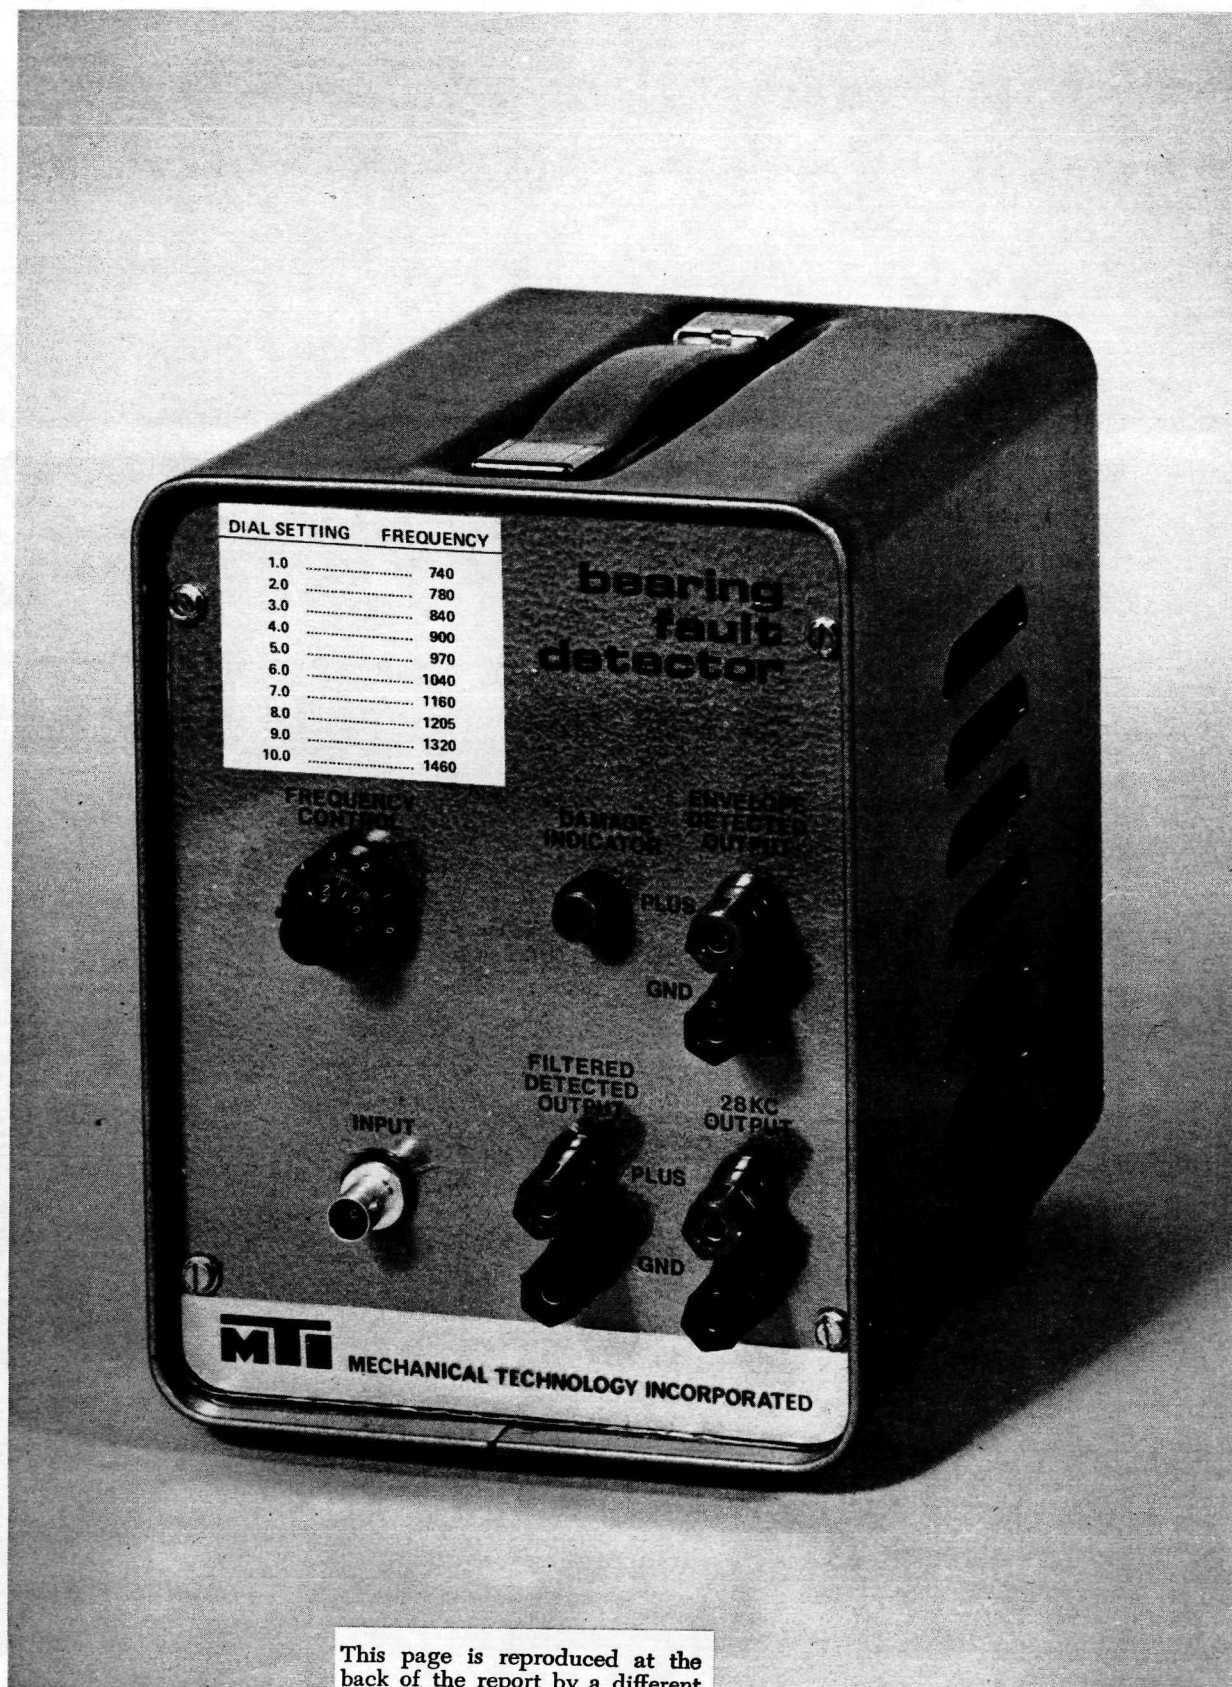
Figure 4 Bearing Fault Detector
